Property Condition Report

Sample – Commercial Building Inspection Report

Prepared By:
Structure & Site
Inspection Services LLC

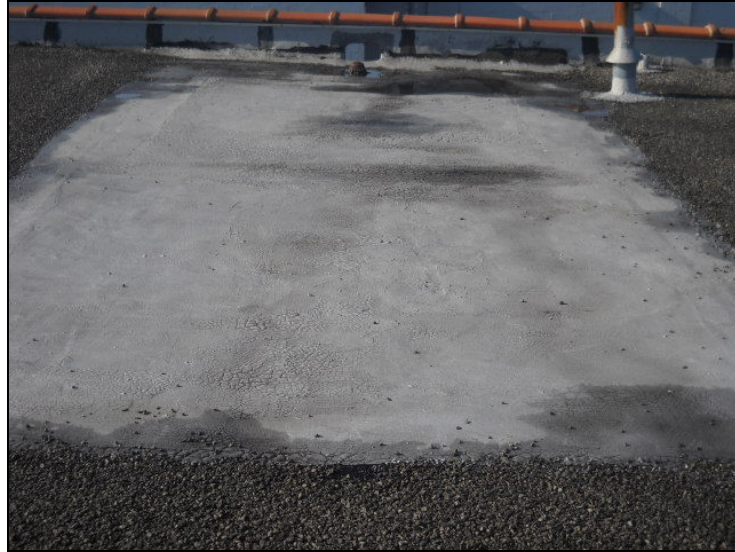
Areas of patched material.

- **Monitor:** The roofing is in fair condition. We did not see evidence of active leaks nor need for immediate major repair.
- **Repair:** Repairs to the roofing are needed. Damaged or missing roofing material should be repaired. All roof penetrations should be examined and sealed as necessary.
- **Monitor:** Prior repairs to the roofing are evident. This would suggest that problems have been experienced in the past. This area should be monitored.

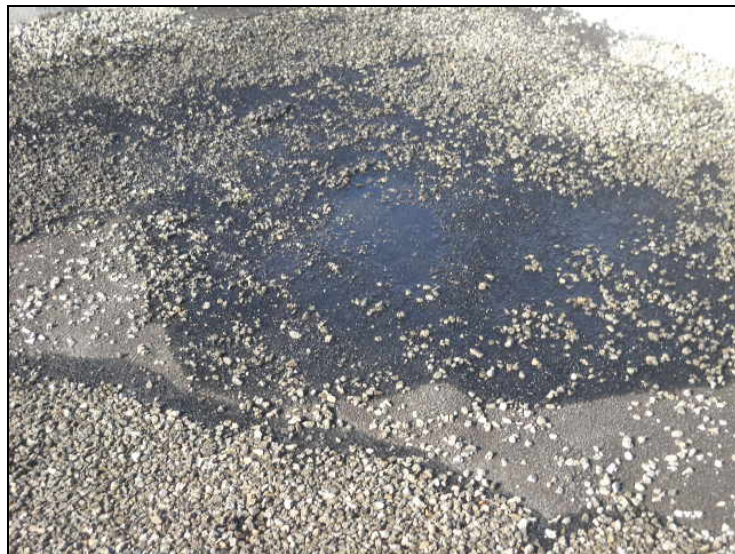
Areas of missing gravel.

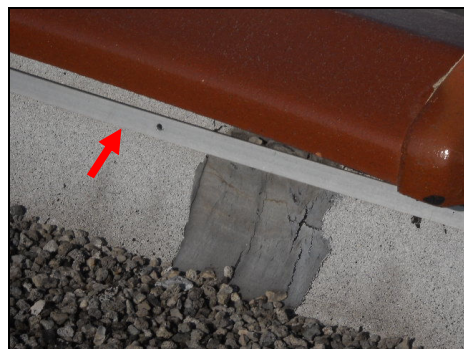
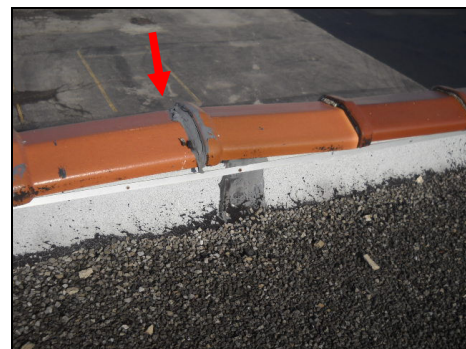
Loose support bands and coping observed at multiple areas.

- **Repair:** The flashing is loose and should be re-secured to avoid leaks.

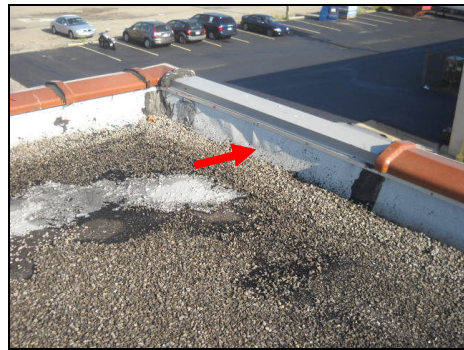
Loose material at parapet wall.

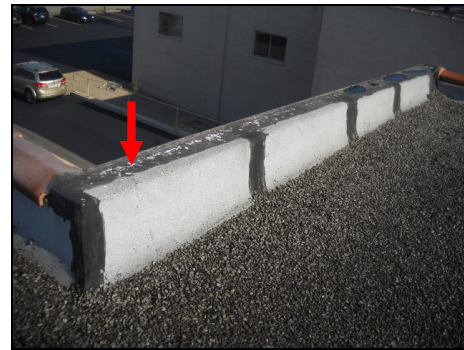
Missing coping on parapet wall.

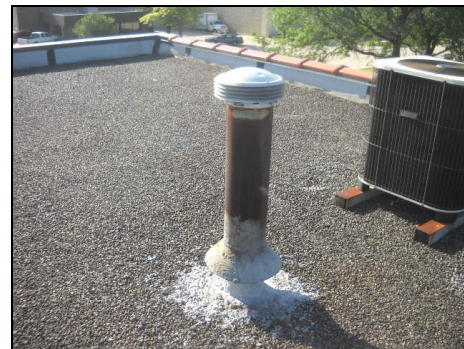
Surface corrosion on chimneys.

- **Repair:** The metal chimney is rusting. It should be painted with an appropriate paint or replaced.

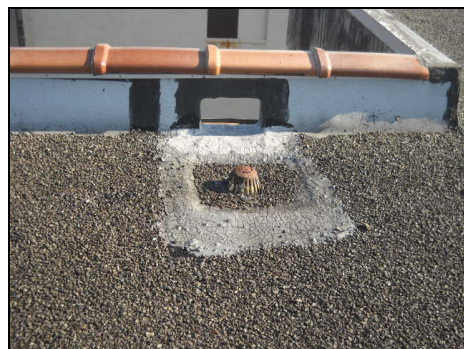
Roof drains need to be cleared of debris.

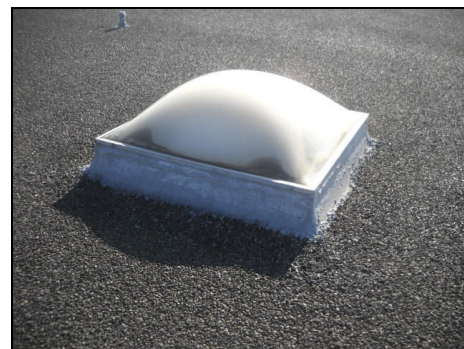
Skylight flashing needs caulking.

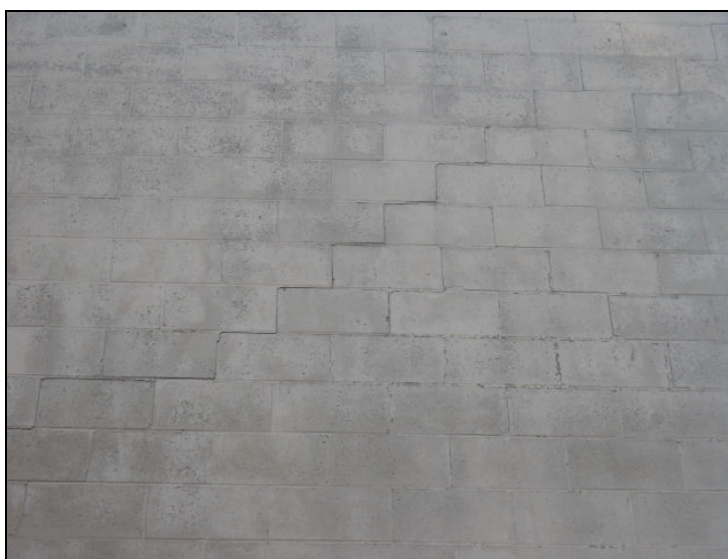
General condition of block exterior wall.

- **Repair:** Localized pointing of deteriorated mortar between the bricks of the exterior walls is advisable to prevent further deterioration.
- **Repair:** The block should be painted to preserve the material.

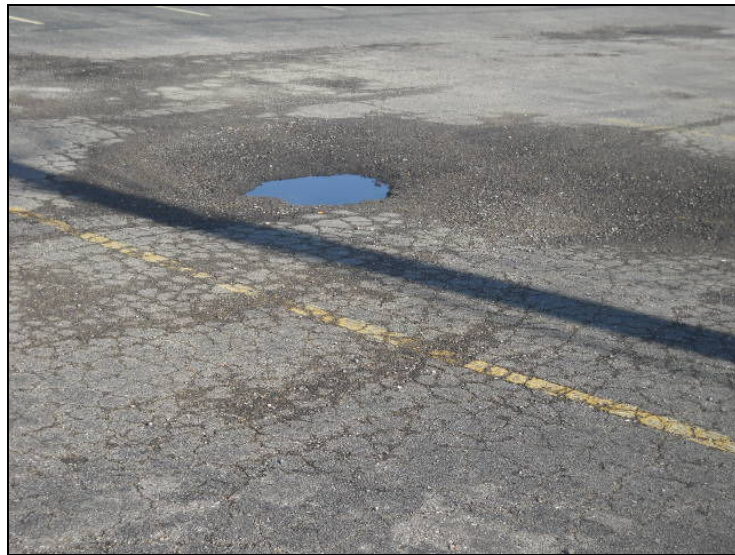
General condition of driveway asphalt.

- **Repair:** The driveway surface is in a semi-deteriorated condition. Resurfacing is necessary to correct this condition.

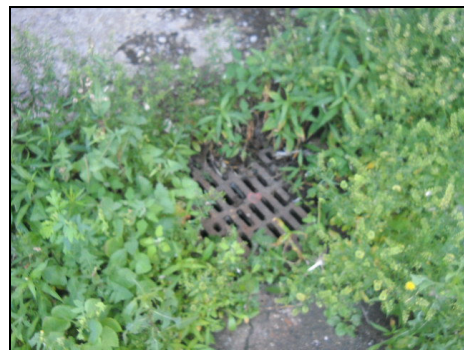
Vegetation and debris needs to be cleared from truck well drain.

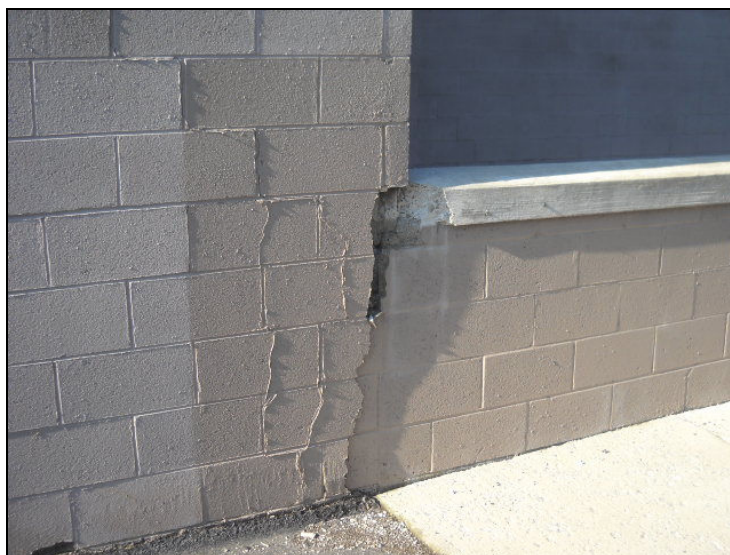
- **Monitor:** The retaining wall shows evidence of movement. This condition should be monitored. It is impossible to determine the rate of movement during a one time visit to the building.

Block and cap damage at retaining wall for truck well.

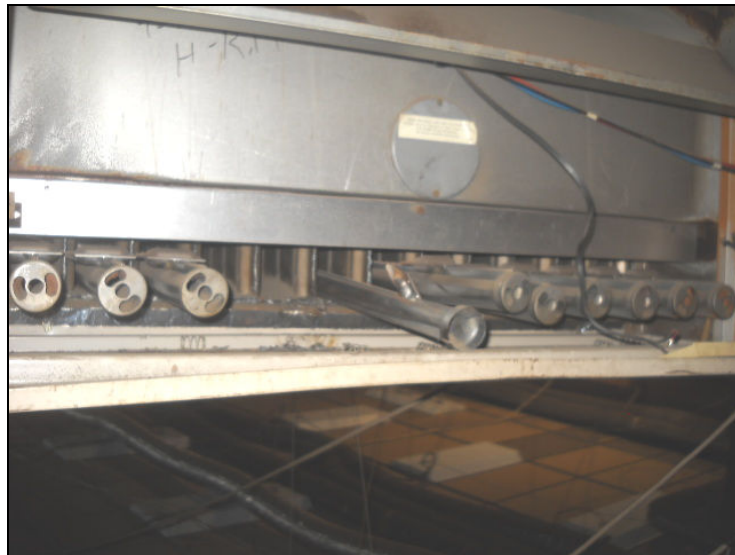
Unitary heating system partially dismantled.

- **Improve:** The heating systems require immediate service. Not all systems functional at time of inspection. Furnace systems have a typical life span of 20 years if properly maintained. Units over 5 years old risk cracked heat exchangers and should be routinely checked by a professional heating technician. A heat exchanger is mostly concealed, requires partial disassembly of furnace components for full viewing and is beyond the scope of a building inspection. Annual maintenance is recommended to assure safe, reliable heat.
- **Monitor: Deferred Cost:** Given the age of the furnace, it may be near the end of its useful life. You should reserve funds to be ready to purchase a new furnace.

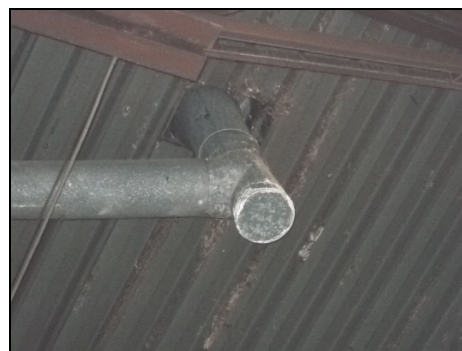
Evidence of roof leakage at chimney protrusion.

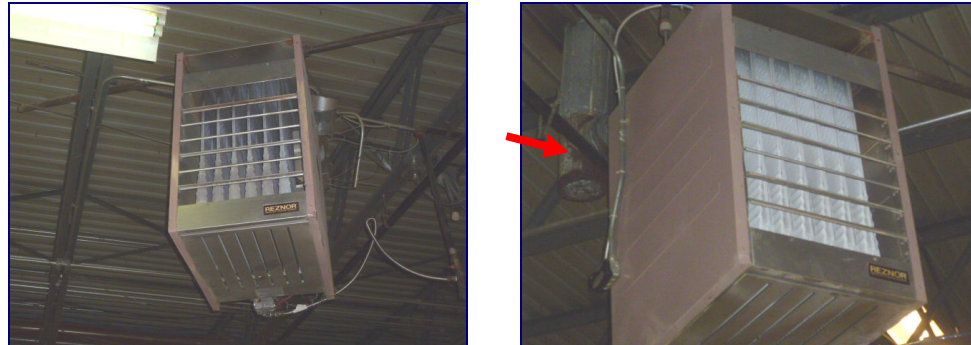
Representative view of warehouse units. Note the corrosion on the vent stack – probable flashing leak at roof.

- **Repair, Safety Issue:** *Poor exhaust flue connections should be improved immediately.* Poor connections risk flue gas and carbon monoxide leakage or other unsafe conditions.

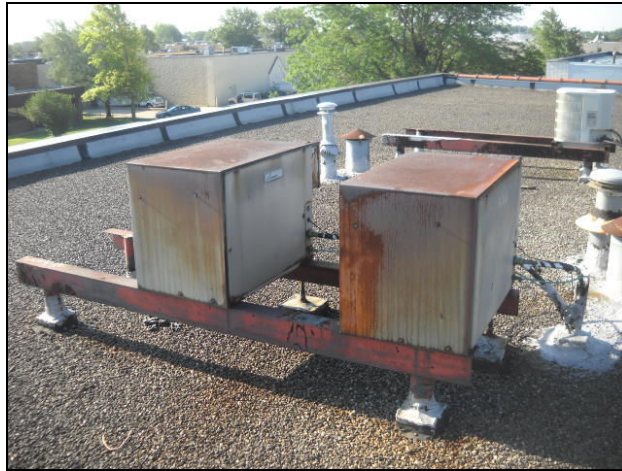
Two condenser units serving east side. These units are 20+ years old.

- Repair:** Three of the air conditioning systems are relatively old. Not all systems functional at time of inspection. They will require a higher level of maintenance, and may be more prone to major component breakdown. Predicting the frequency or time frame for repairs on any mechanical device is virtually impossible. If the compressor fails, or if breakdowns become chronic, replacing the entire system may be more cost-effective than continuing to undertake repairs.

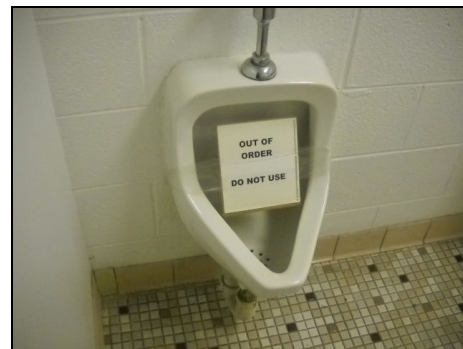
Out of order urinal.

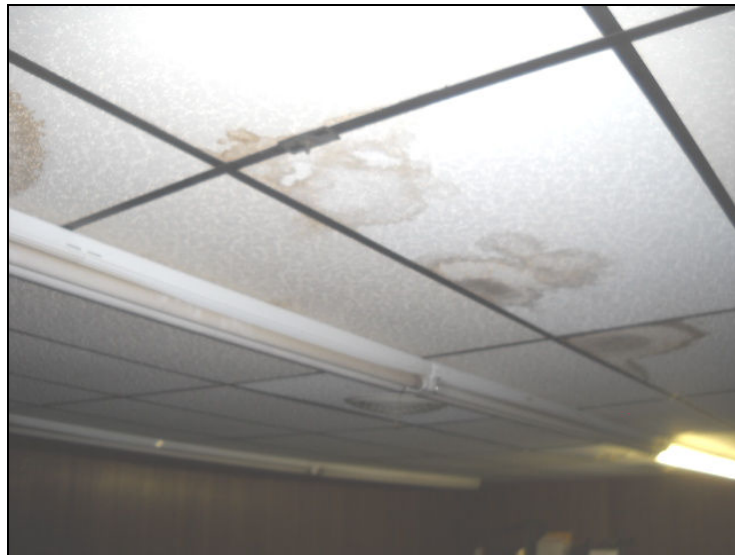
- **Monitor:** Water staining was noted in various ceiling tiles on the 2nd floor and within the warehouse walls indicating roof leakage.

Multiple areas of ceiling tile water staining observed on 2nd floor.

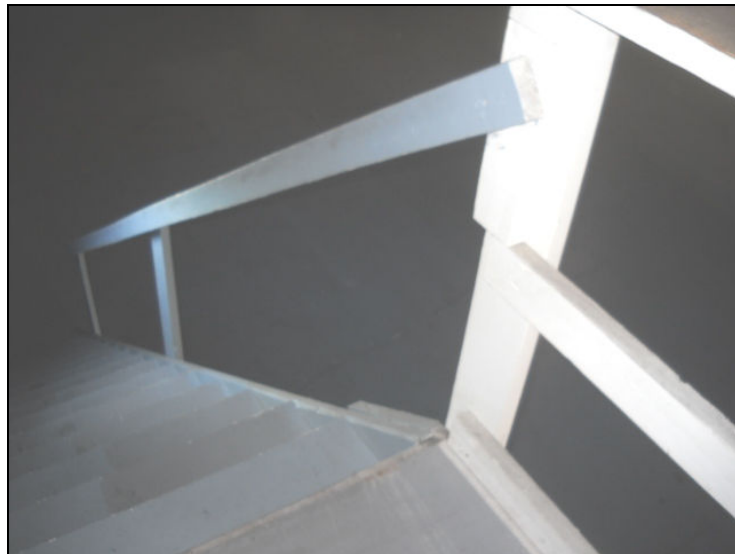
The railing construction for the warehouse staircase is improper and presents a safety risk.

- **Repair:** The railing for the stairway is loose and does not offer proper protection due to the width of the railing.
- **Repair, Safety Issue:** The height of the stairway railing may not be sufficient to prevent a person from toppling over the railing. It is recommended that this condition be altered for improved safety.

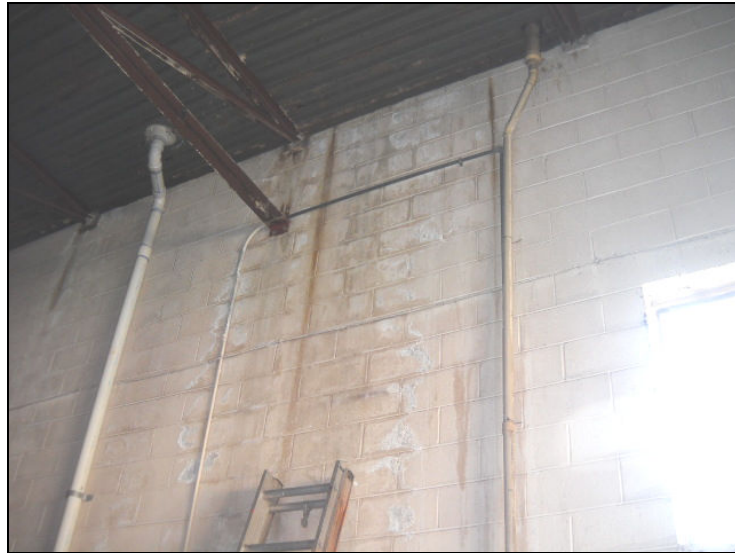
Internal water staining from roof leakage.

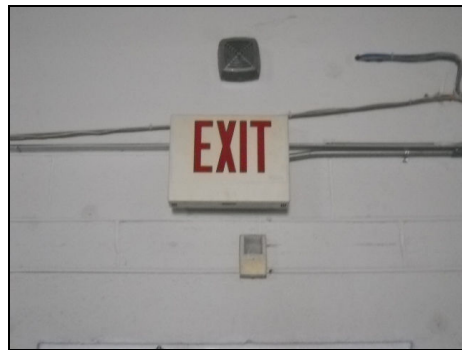
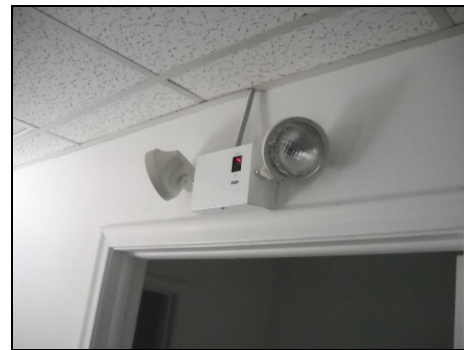
- **Repair:** Not all equipment observed functional. All equipment must be tested and certified.

Representative view of installed fire protection equipment.

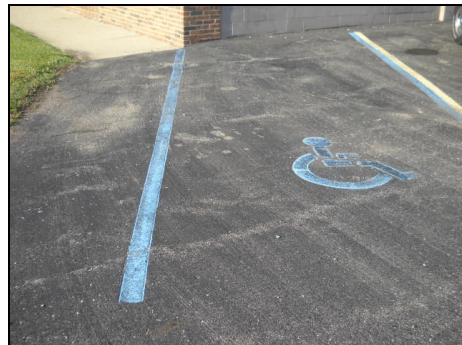
Present, yet insufficient ADA parking.

- **Repair:** Recommend re-stripping parking lot to satisfy ADA requirements.
- **Repair:** Recommend installing proper curb cuts and entrance configuration at front office to accommodate wheelchair access to the building.
